Report No. 080/01

Inspection order: Mechanical charges, climate tests

Tested Item: Outdoor Cabinet 2000x700x700mm

Customer specification: IEC 61969-3 class 1

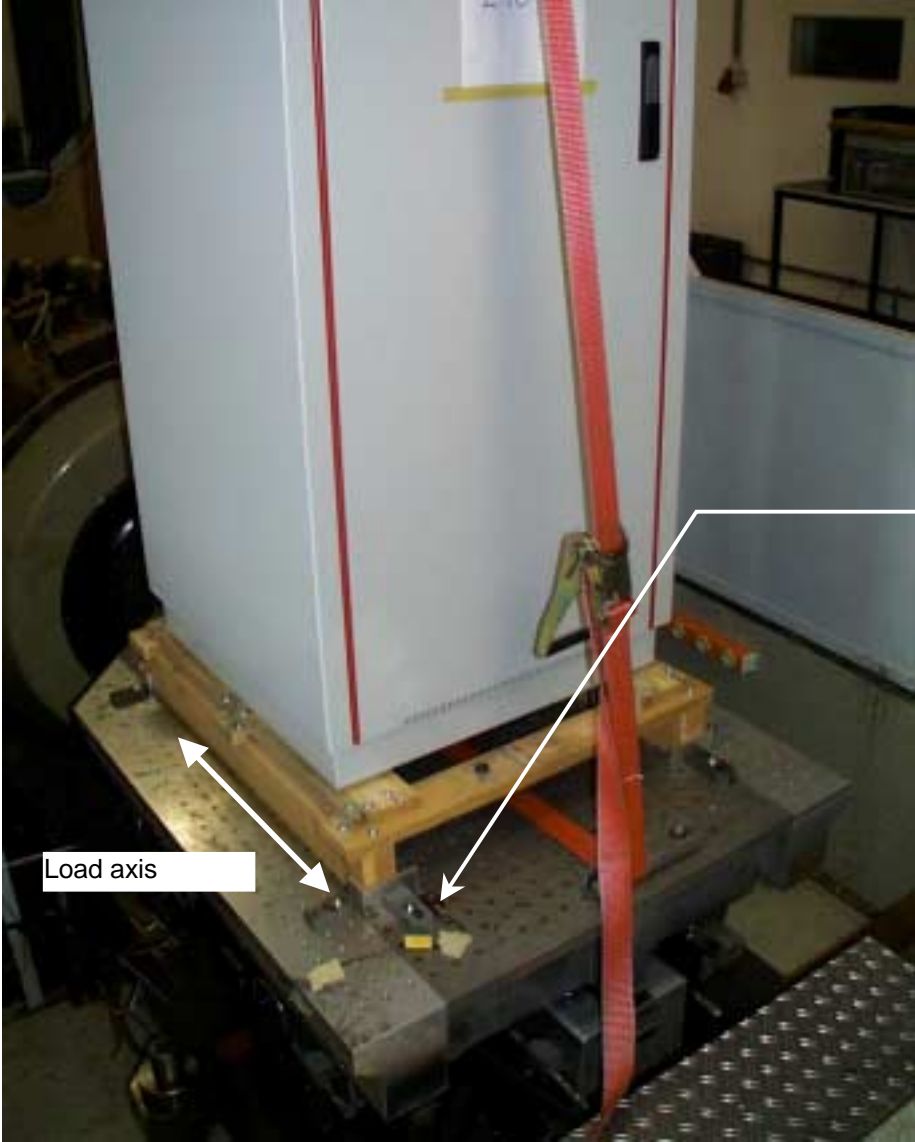
Picture 1

Test	Ref.	Axis/Set-up	Type of Strain / Remarks	Time / Doc.
				21st March 2002
				Schrank Nr. 1 14990/037
# 1	2.1	X axis (Picture 1)	Vibration - sinusoidal, 10 cycles Acceleration procedure control channel	2:23:41 h Enclosure 1
				Visual control inside and out <u>Result: No damage detectable</u>

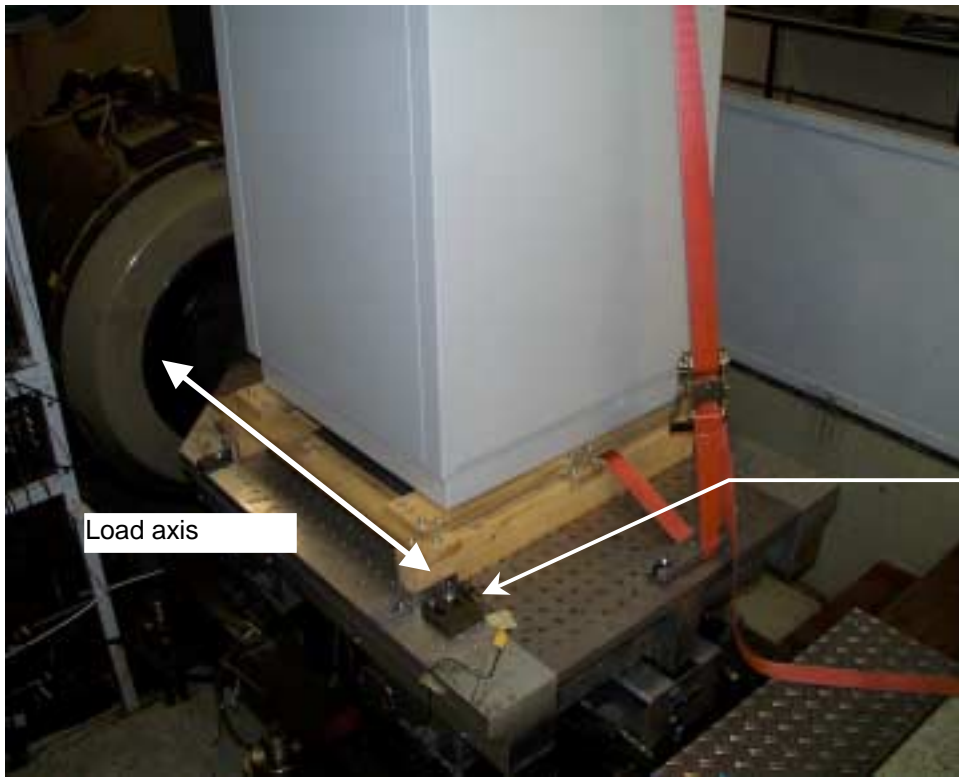
Picture 2

# 2	2.1	Y axis (Picture 2)	Vibration - sinusoidal, 10 cycles Acceleration procedure control channel	2:23:41 h Enclosure 2
				Visual control inside and out <u>Result: No damage detectable</u>
				22th March 2002

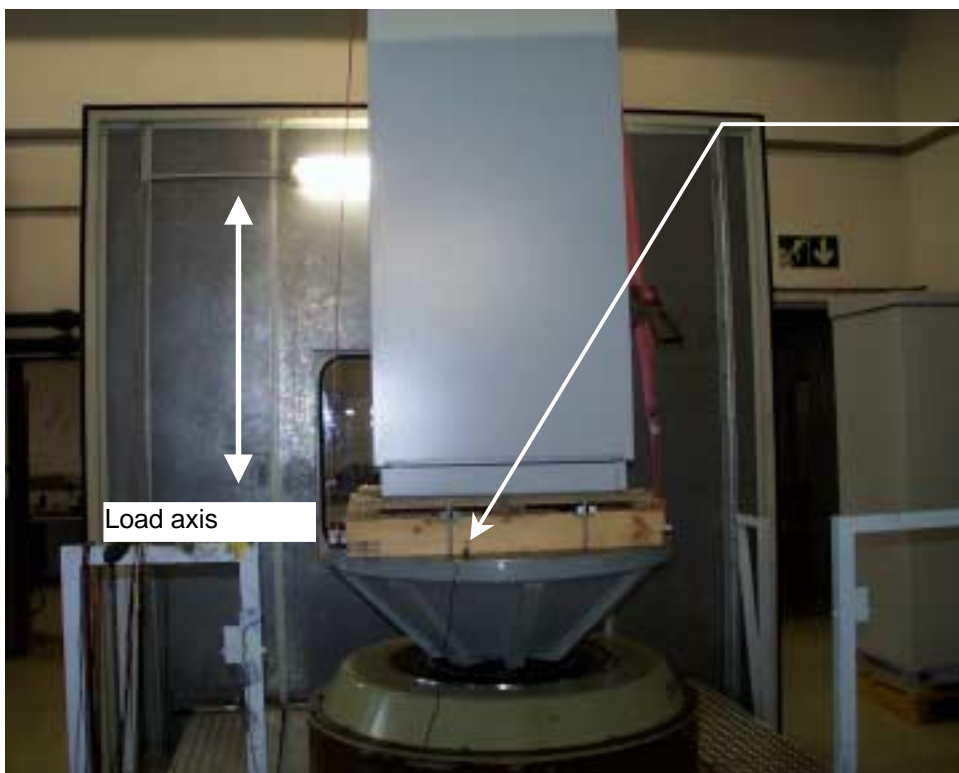
Picture 3

# 3	2.1	Z axis (Picture 3)	Vibration - sinusoidal, 10 cycles Acceleration procedure control channel	2:23:41 h Enclosure 3
				Visual control inside and out <u>Result: No damage detectable</u>

# 4	2.2	Z axis (Picture 3)	Mechanical Shock Acceleration procedure control channel + direction Acceleration procedure control channel + direction <u>Remark: Due to extremely strong reaction of the tested item, the tolerances of the IEC 68-2-27 could not be adhered to.</u>	2:23:41 h Enclosure 4 Enclosure 5
				Visual control inside and out <u>Result: No damage detectable</u>

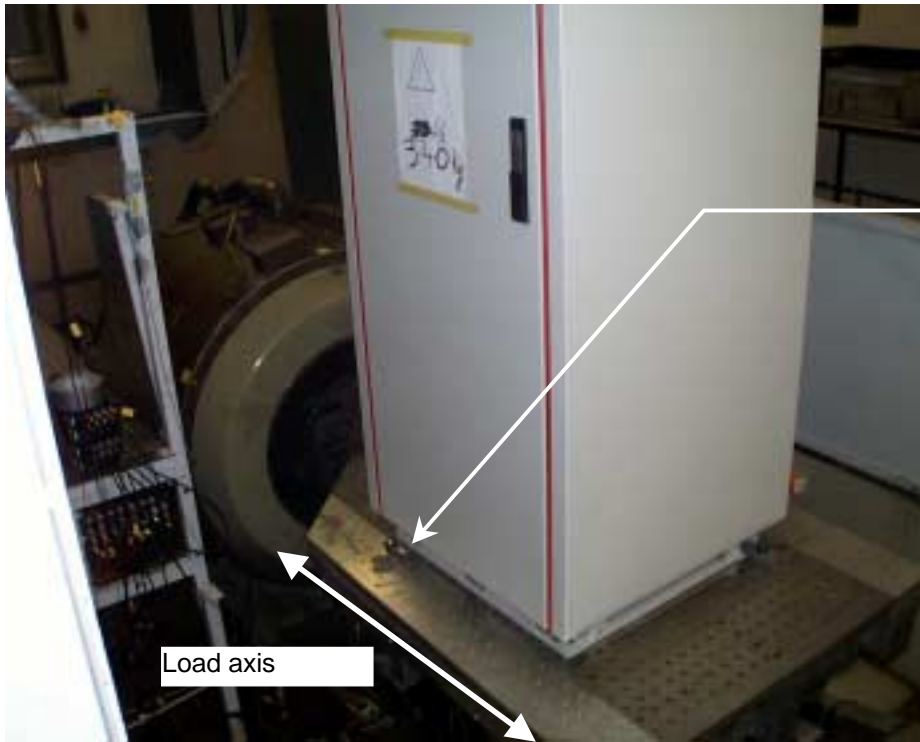
Picture 4

# 5	2.4	vertical (Picture 5)	Free fall	1 fall
				Visual control inside and out <u>Result: No damage detectable</u>
				Schrank Nr. 2 14990/038
# 6	2.3	Z axis (Pictures 4+3)	Seismic test, duration of time Acceleration procedure control channel, time signal Acceleration procedure control channel, amplitude spectrum	15 shocks, 30 s in total Enclosure 6 Enclosure 7
				Visual control inside and out <u>Result: No damage detectable</u>

# 7	2.3	Y axis (Pictures 4+2)	Seismic test, duration of time Acceleration procedure control channel Acceleration procedure control channel, amplitude spectrum	15 shocks, 30 s in total Enclosure 8 Enclosure 9
				Visual control inside and out <u>Result: No damage detectable</u>

# 8	2.3	X axis Pictures 4+1)	Seismic test, duration of time Acceleration procedure control channel Acceleration procedure control channel, amplitude spectrum	15 shocks, 30 s in total Enclosure 10 Enclosure 11
				Visual control inside and out <u>Result: No damage detectable</u>

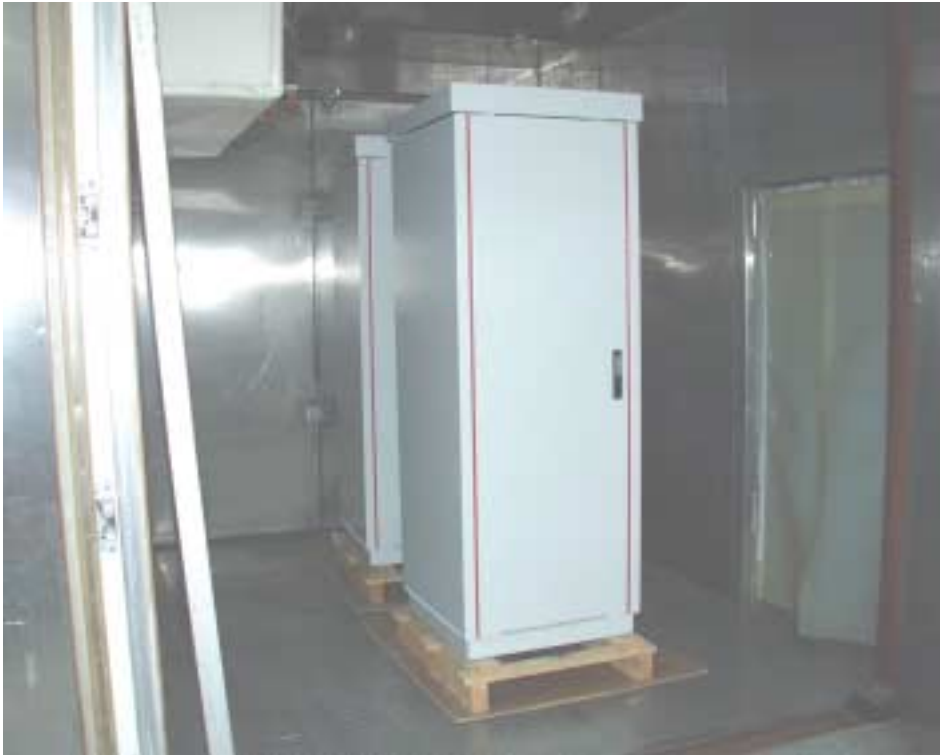
# 9	2.21	Picture 8	Constant cold - 45°C, 16h Temperature progressing Visual control inside and out <u>Result: No damage detectable</u>	22nd - 23rd March 2002 Enclosure 12

# 10	2.22	Picture 8	Dry heat +80°C, 16h Temperature progressing Visual control inside and out <u>Result: No damage detectable</u>	23rd March 2002 Enclosure 13

# 11	2.23	Picture 8	Temperature change -50°C / +23°C, 2 cycles Temperature progressing Visual control inside and out <u>Result: No damage detectable</u>	25th to 26th March 2002 Enclosure 14

# 12	2.24	Picture 8	Humid heat, constant Temperature progressing Remark : The relative humidity was controlled with the temperature of the water bath and was checked manually with a humidity psychrometer. Visual control inside and out <u>Result: No damage detectable</u>	26th to 30th March 2002 Enclosure 15

# 13	2.25	Picture 8	Humid heat, cyclic Temperature progressing Remark : The relative humidity was controlled with the temperature of the water bath and was checked manually with a humidity psychrometer. Visual control inside and out <u>Result: No damage detectable</u>	2nd to 6th April 2002 Enclosure 16
