Test Report

Vibration tests

Unit under test (UUT)	Type designation	Identification no.
Sub-rack	europac Pro fer 6 U 84 HP (21T) 320D	test setup I to III acc. NF F 67-012

Client	Manufacturer
Schroff GmbH Langenalber Strasse 96 - 100 D - 75334 Straubenhardt	see client

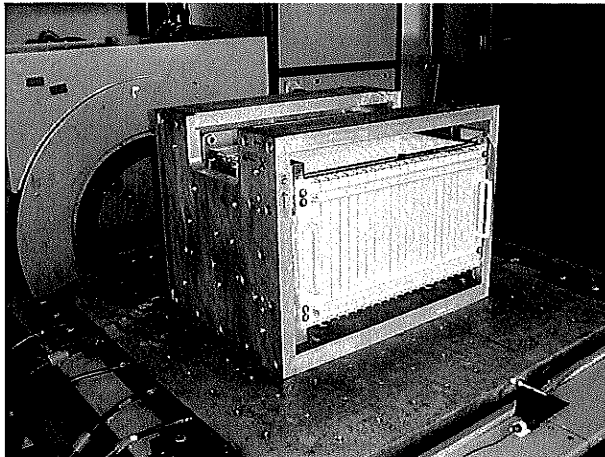
Photo 7: X-axis test setup I
