## Release Note

### Schroff firmware part number 63998-05161

### Based on Pigeon Point Systems (PPS) firmware release 2.4.2 for ShMM-300

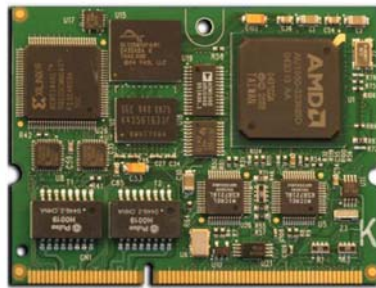
**Note:** This release note only applies to shelf manager carrier boards which have the Pigeon Point Systems **ShMM-300 Module** installed. Before proceeding with this firmware installation, please make sure that your shelf manager is equipped with a ShMM-300 module. The photo below shows the ShMM-500 and the ShMM-300 modules

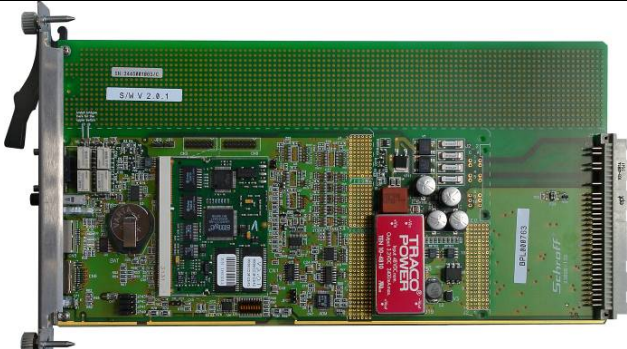
| Photo | Type | RC2-variable |
|---|---|---|
| | ACB-II | rc.acb2 |

The overview below shows the different versions of Schroff Shelf Manager carrier board.
