**Release Notes**  
**nVent/Schroff firmware part number 63998-53470**  
**Based on Pigeon Point Systems (PPS) firmware release V3.7.1 for ShMM-700**

**Release Date: July 12, 2018**

The firmware package “63998-53470.zip” contains Firmware release V3.7.1 for the **ShMM-700**. The PPS supplied APP image has been modified by nVent/Schroff to adapt the firmware to nVent/Schroff ATCA shelves. The kernel and RFS images have not been modified and are identical to the PPS kernel and RFS images. The U-boot environment has been modified to reflect the necessary non-volatile system settings for this firmware running on nVent/Schroff shelf managers. The nVent/Schroff part number for this firmware release is 63998-53470.

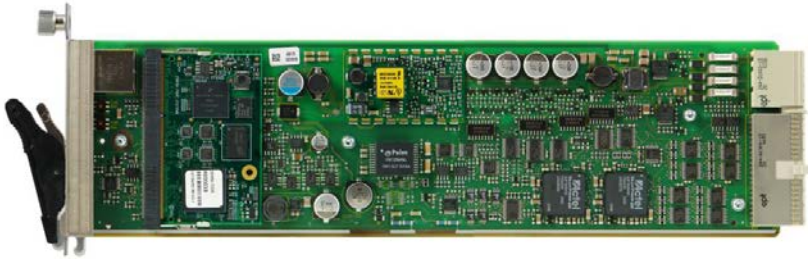
The table below shows the nVent/Schroff shelf manager versions, please identify your shelf manager type. You will need the corresponding RC2-variable later in the upgrade process.

<p>The part number of the ACB-VI shelf manager is on the label at the rear side of the shelf manager, see photo below:</p> <div> <div> - Bused IPMB version: P/N = 21990-401 - Radial IPMB version: P/N = 21990-402 </div>

</div> </div>	ACB-VI	rc.acb6-HPDL
